BELTZVILLE LAKE CONDITION REPORT, DAM, OUTLET WORKS AND SPILLWA--ETC(U)

LEHIGH RIVER BASIN  
POHOPOCO CREEK, PENNSYLVANIA  
**BELTZVILLE LAKE**

CONDITION REPORT

DAM, OUTLET WORKS & SPILLWAY,  
PERIODIC INSPECTION REPORTS NO. 3 & NO. 4,  
SEPTEMBER 1972 & AUGUST 1973

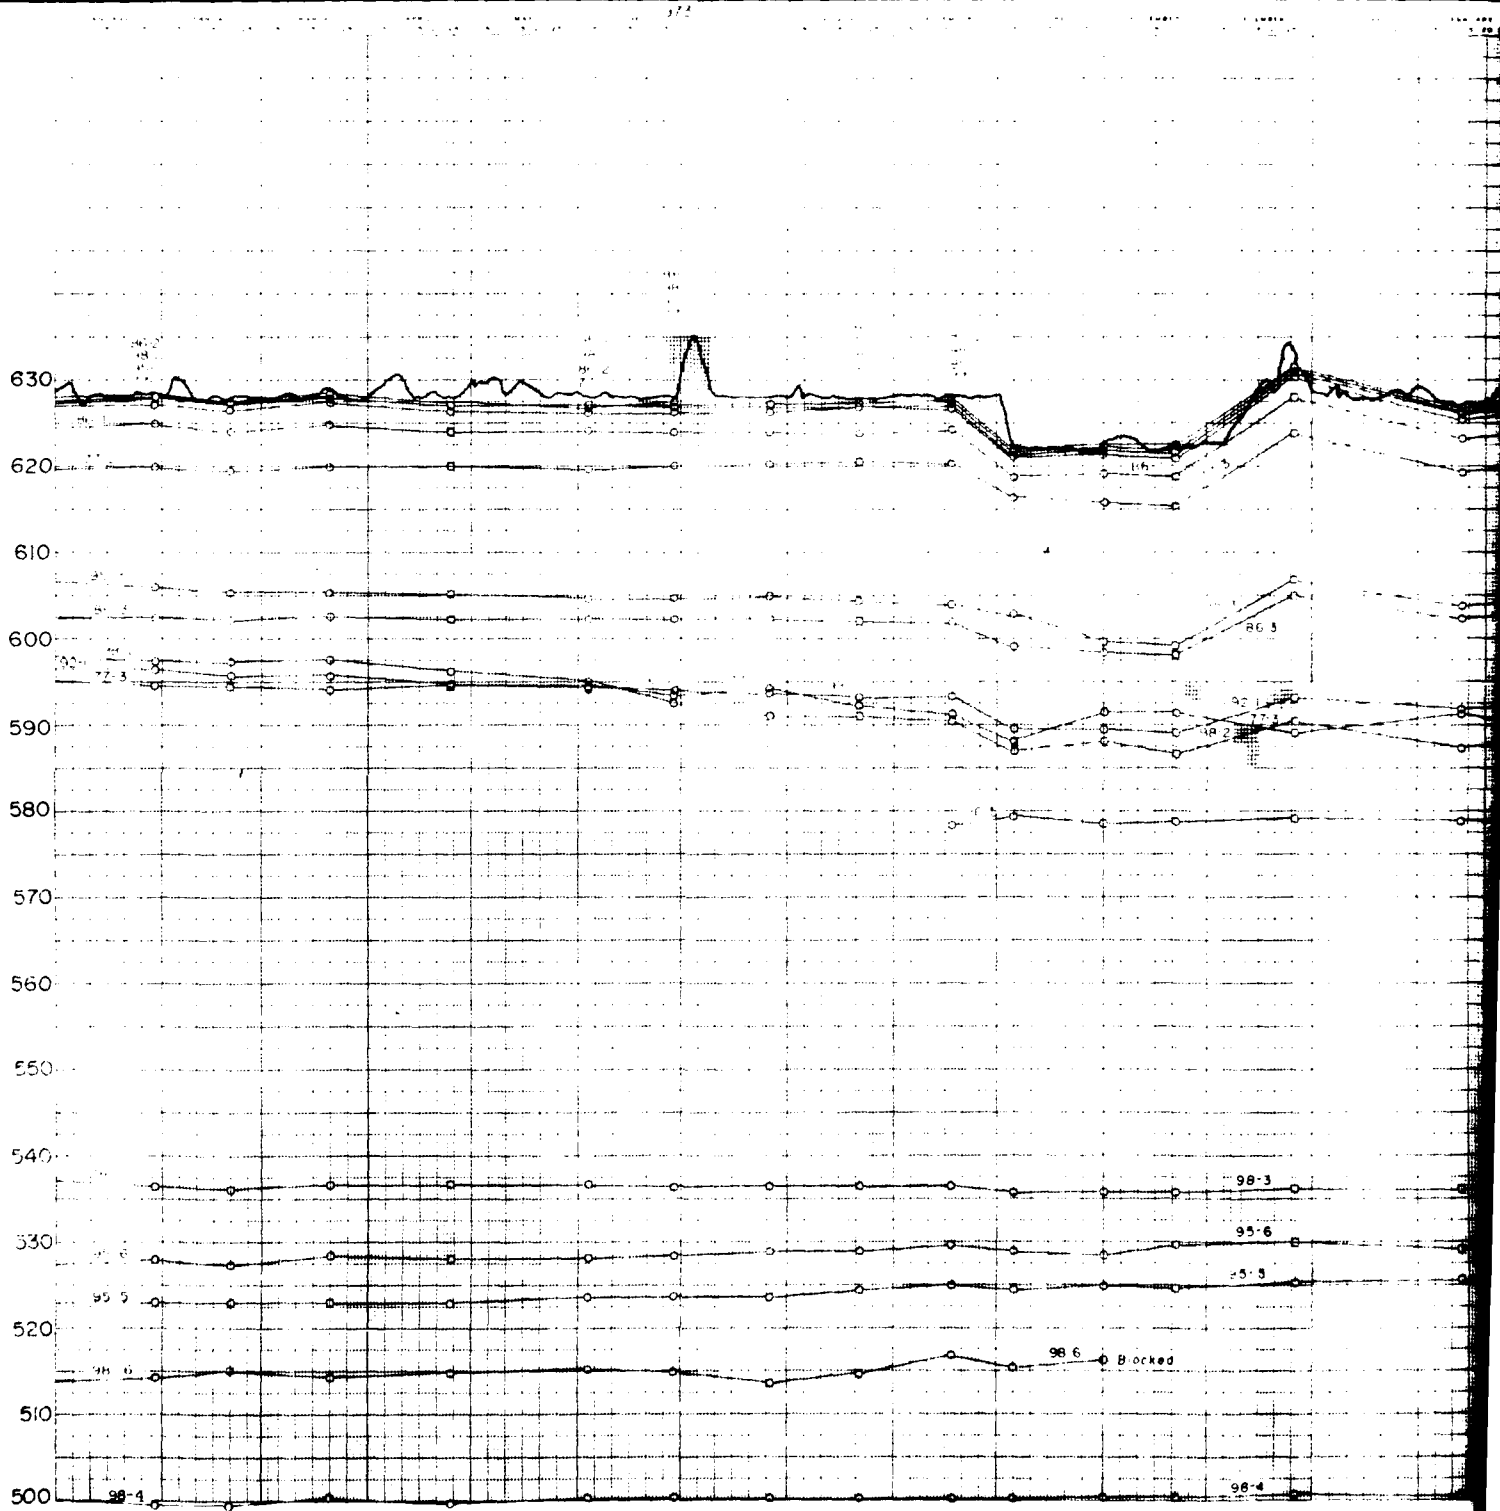
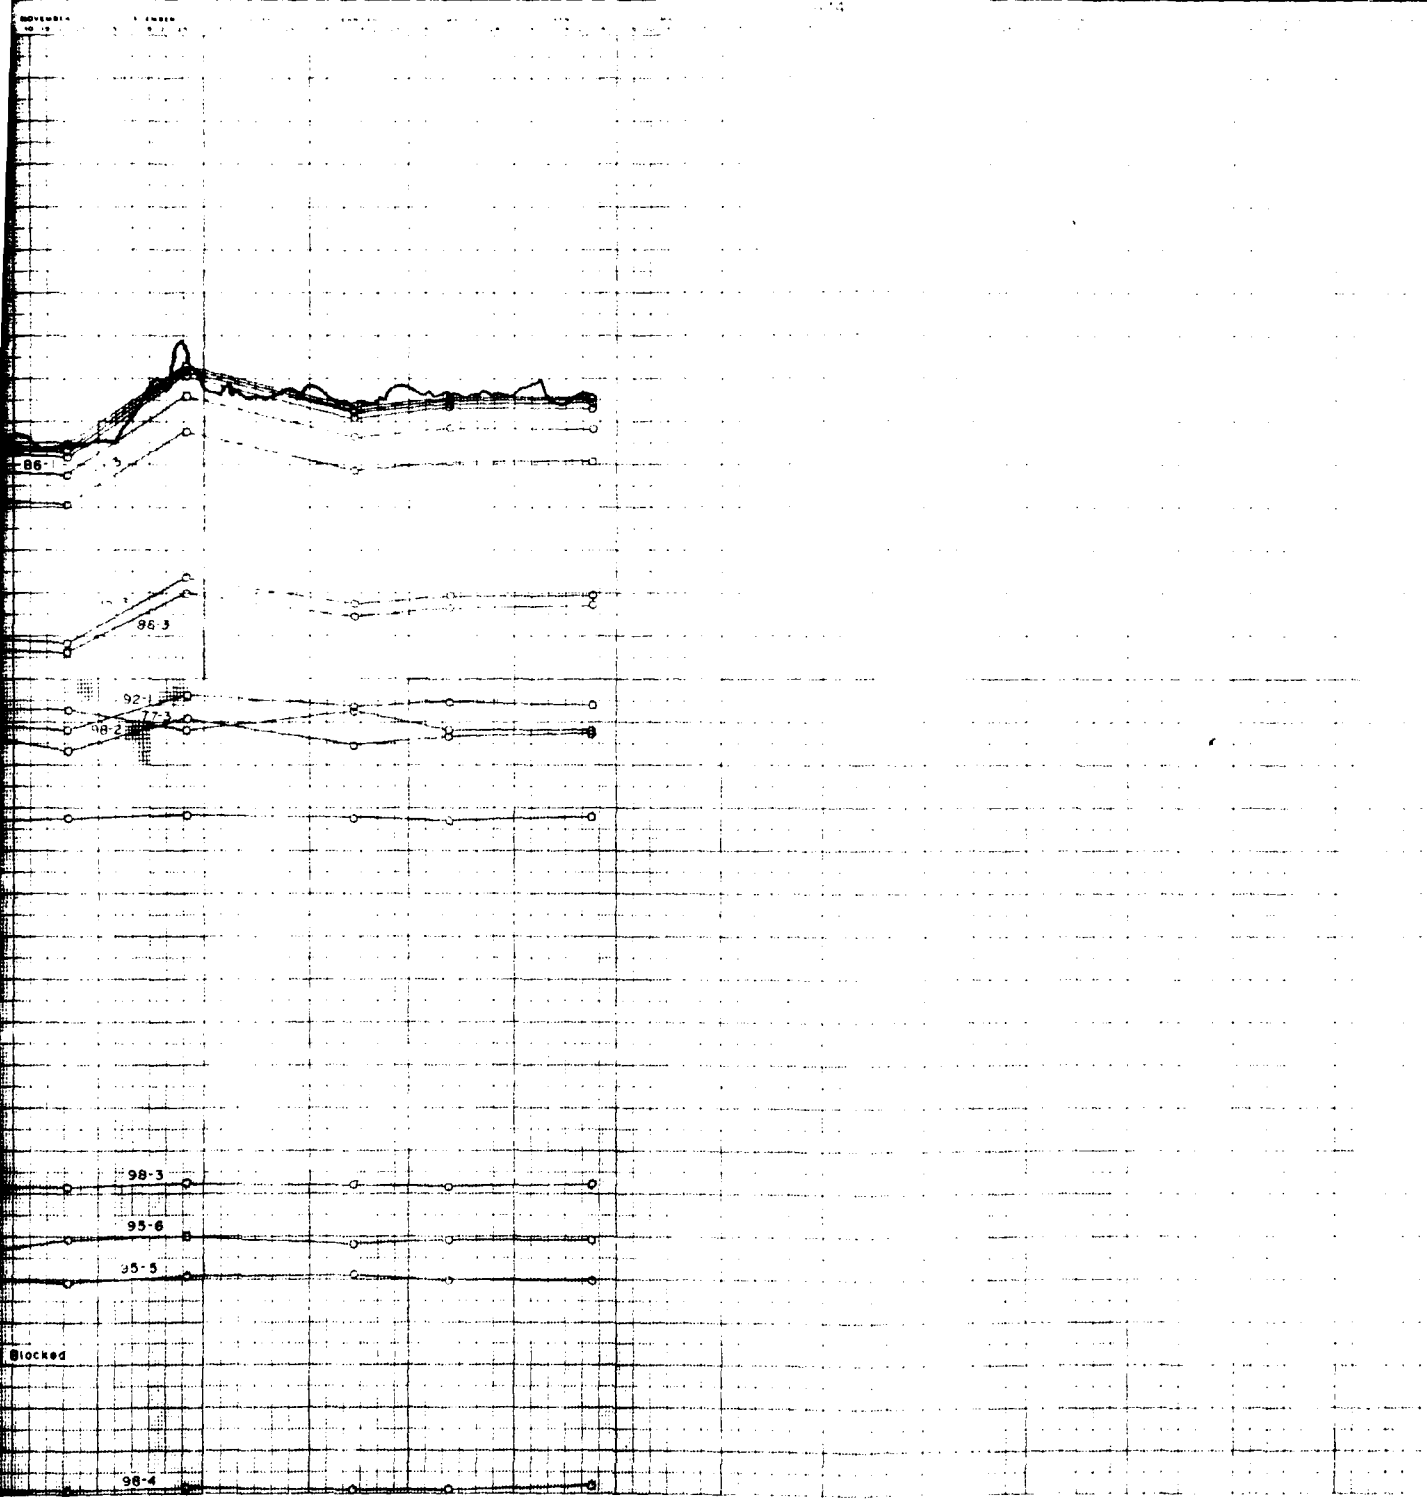
PIEZOMETER DATA  
1973-1974

LEHIGH RIVER BASIN  
POHOPOCO CREEK, PA  
BELTZVILLE LAKE

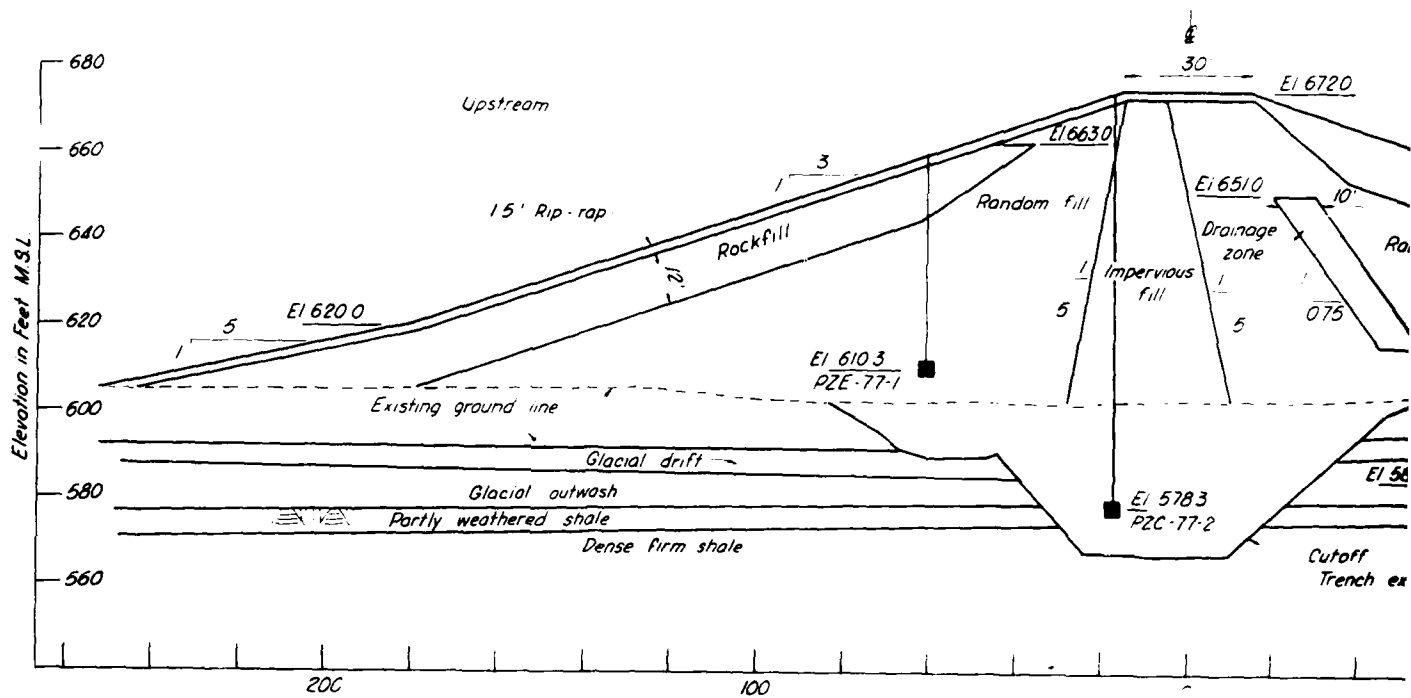
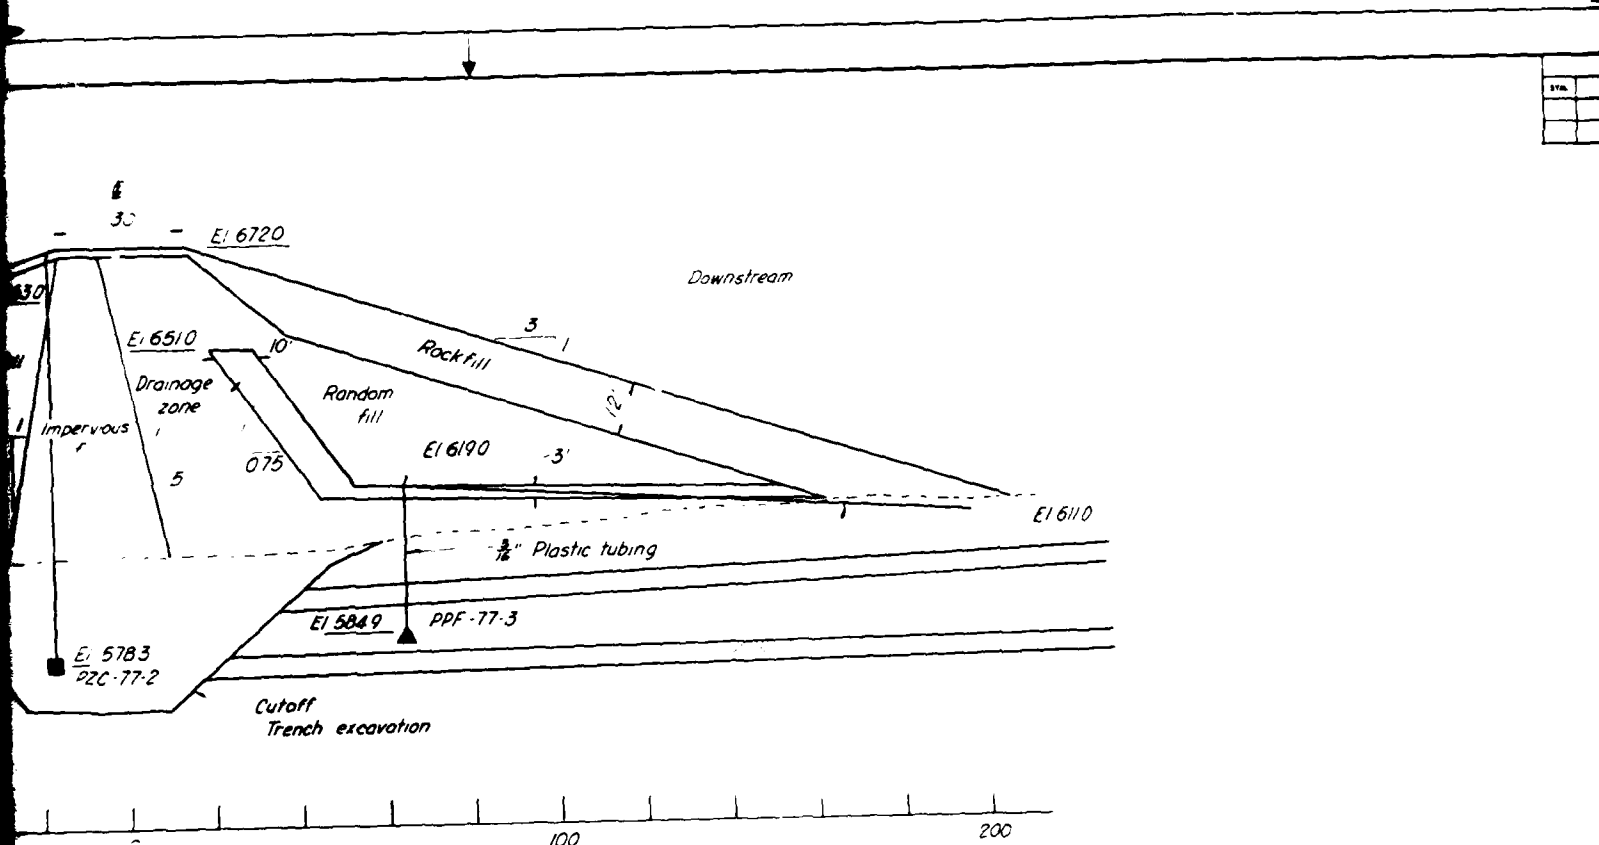
INSTRUMENTATION LINE  
 STATION 7+770

STATION 7 + 770

LEHIGH RIVER BASIN  
 BELTZVILLE LAKE  
 POHOPOCO CREEK, PENNSYLVANIA

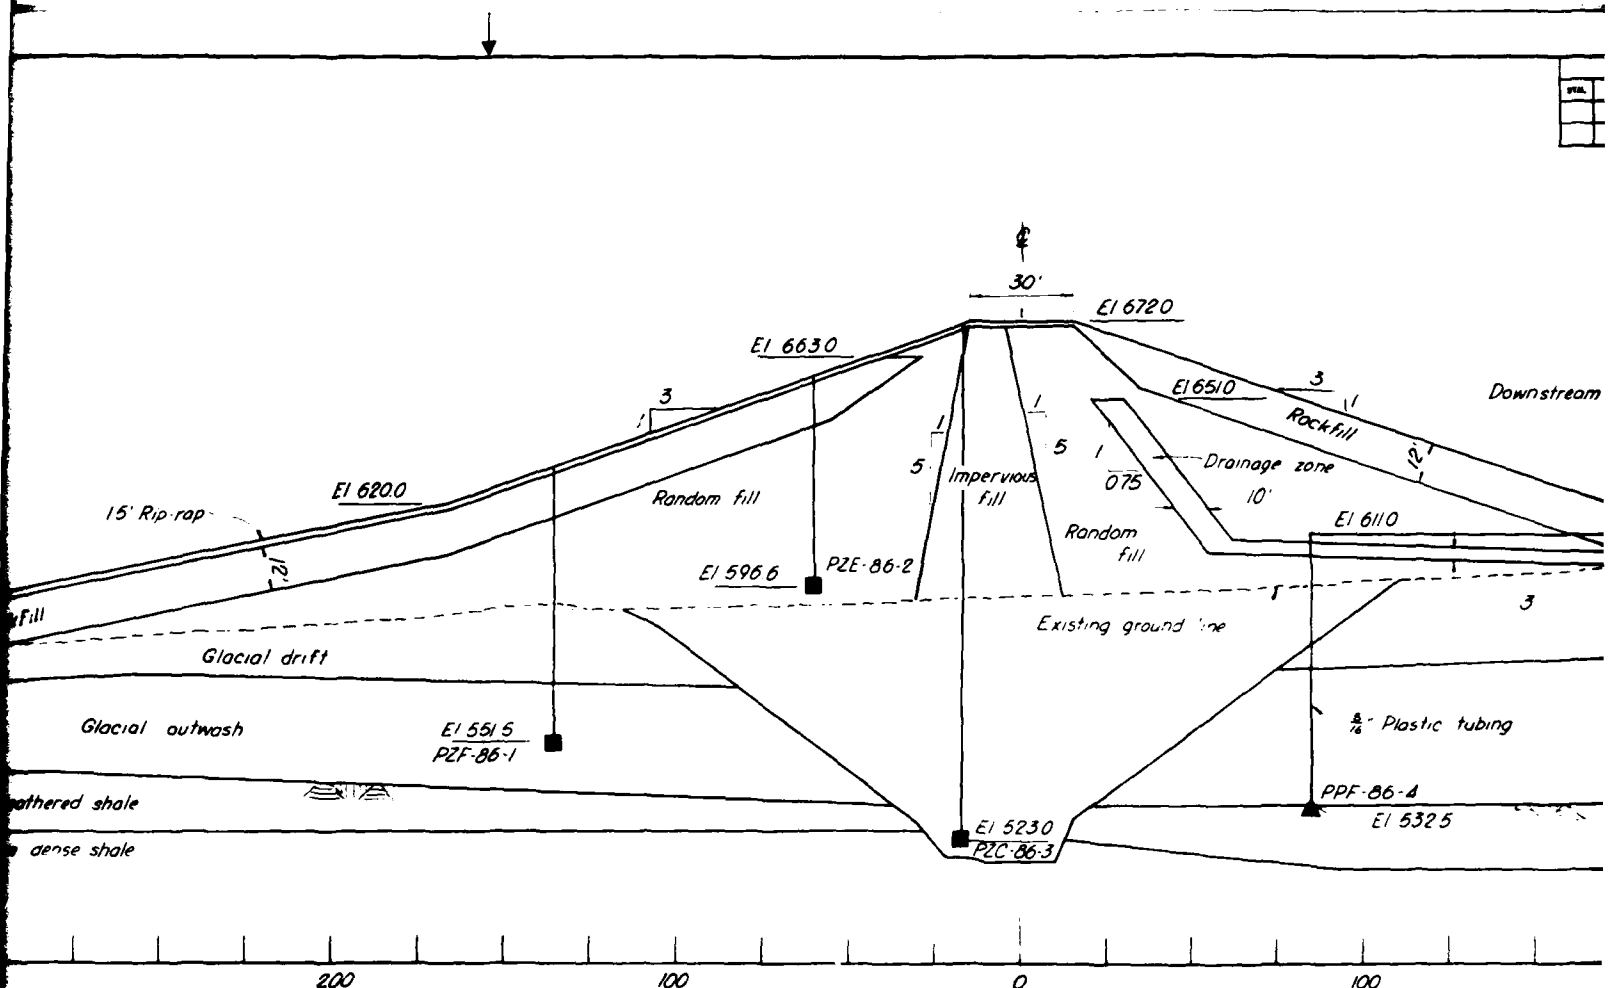
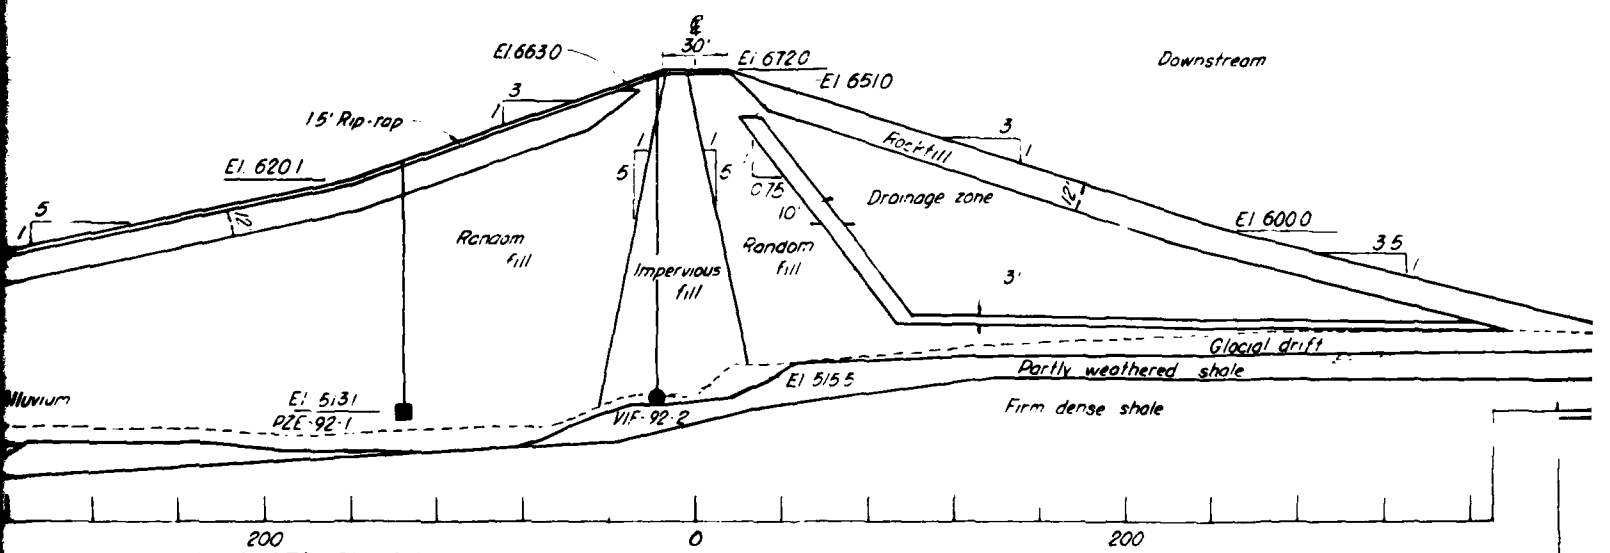
INSTRUMENTATION LINE  
 STATION 8+600 @ STATION 9+280

200  
AXIS STATION 8 + 600

200  
AXIS STATION 9 + 280

LEHIGH RIVER BASIN  
 BELTZVILLE LAKE  
 POHOPOCO CREEK, PENNSYLVANIA

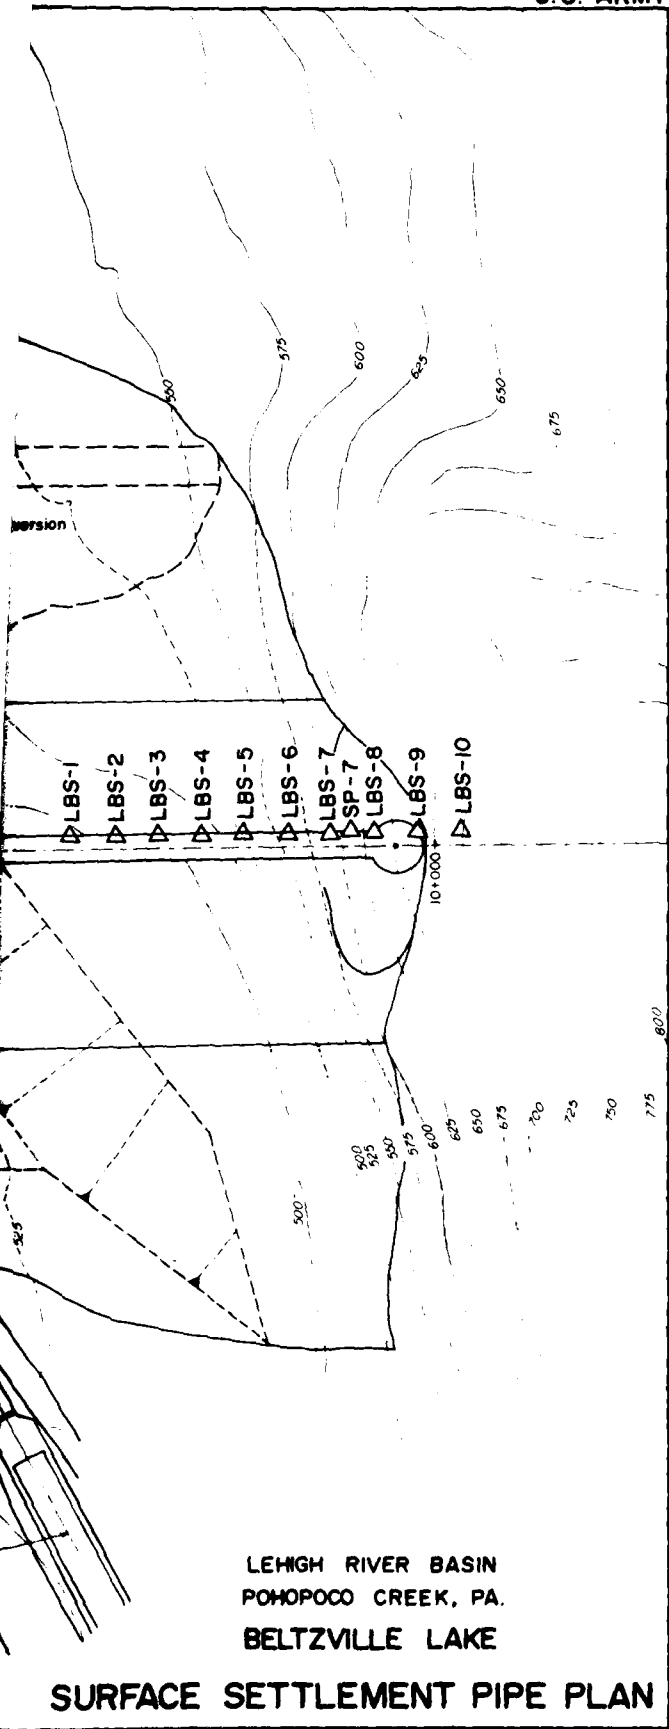
SURFACE SETTLEMENT PIPE PLAN

LEHIGH RIVER BASIN  
POHOPOCO CREEK, PA.  
BELTZVILLE LAKE

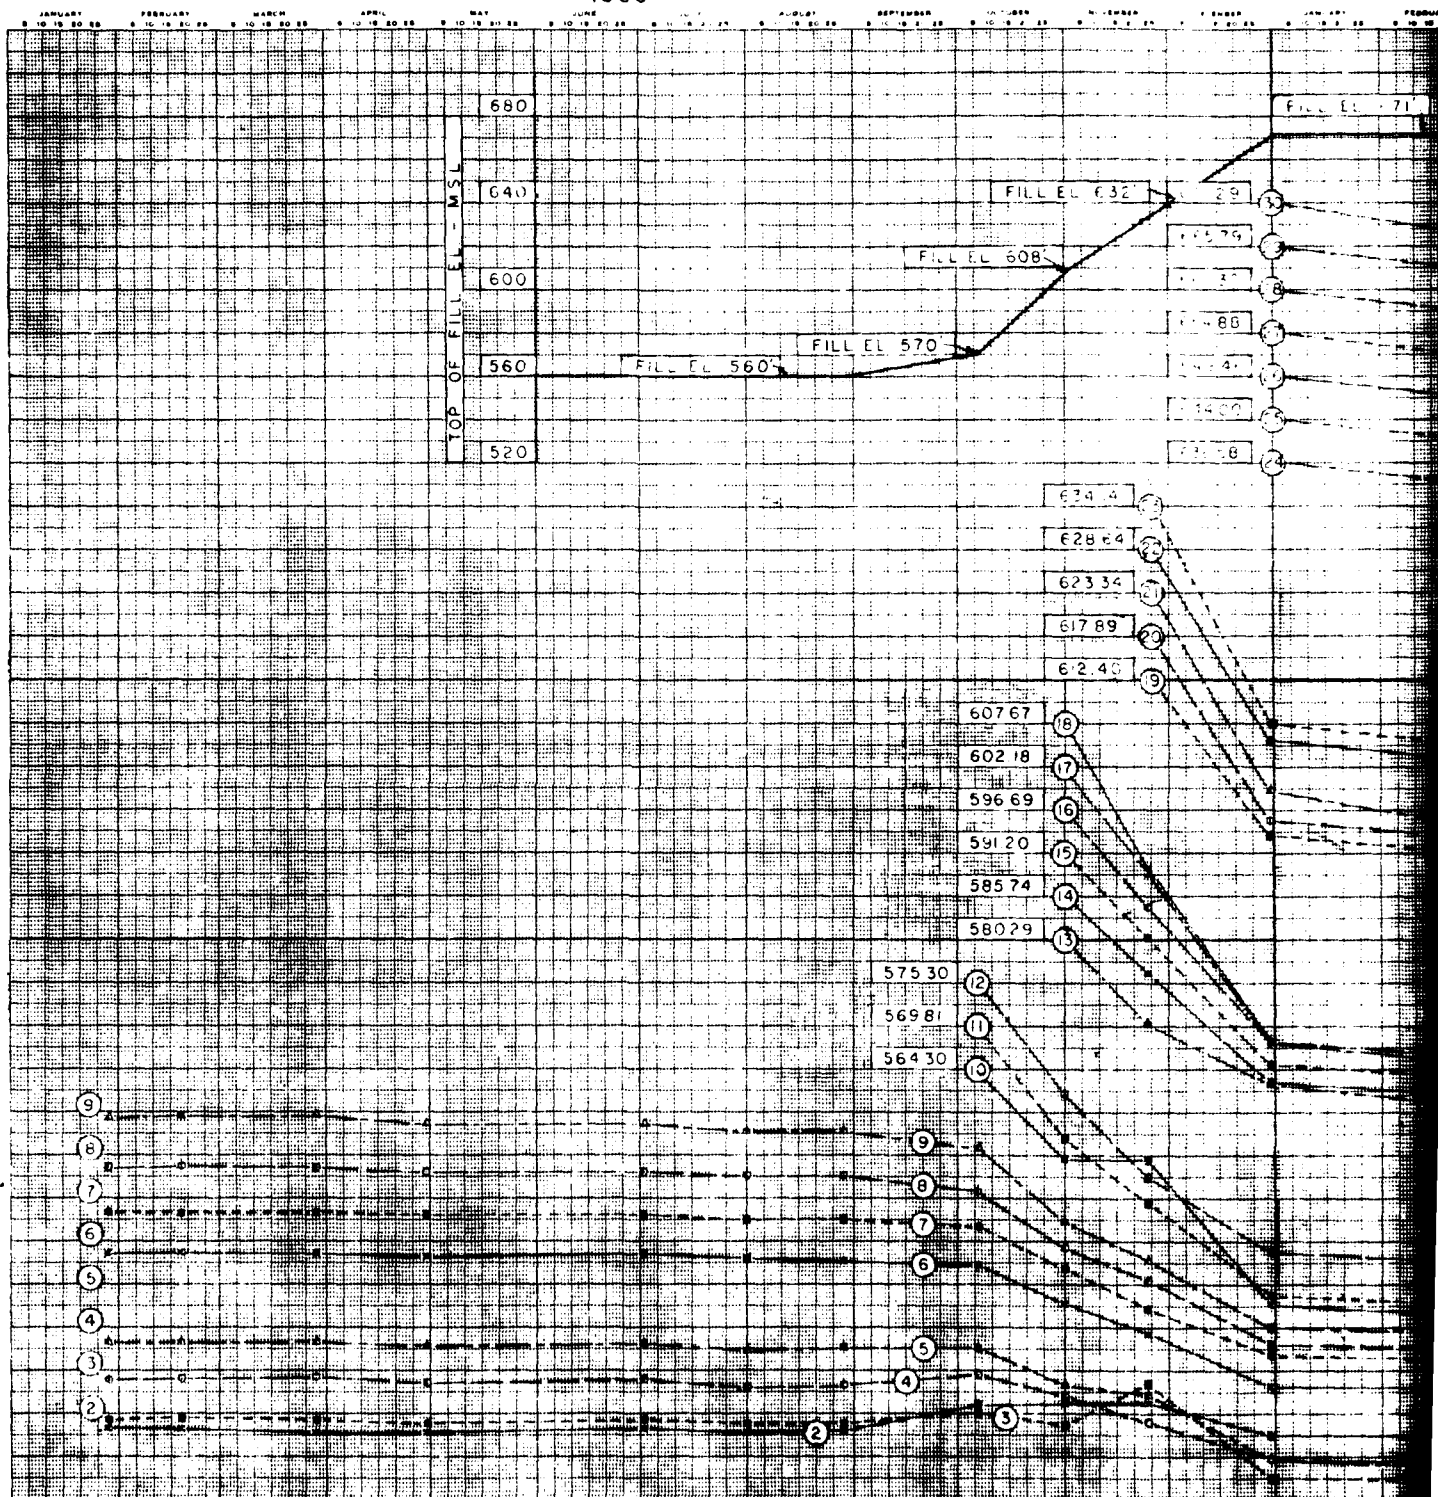
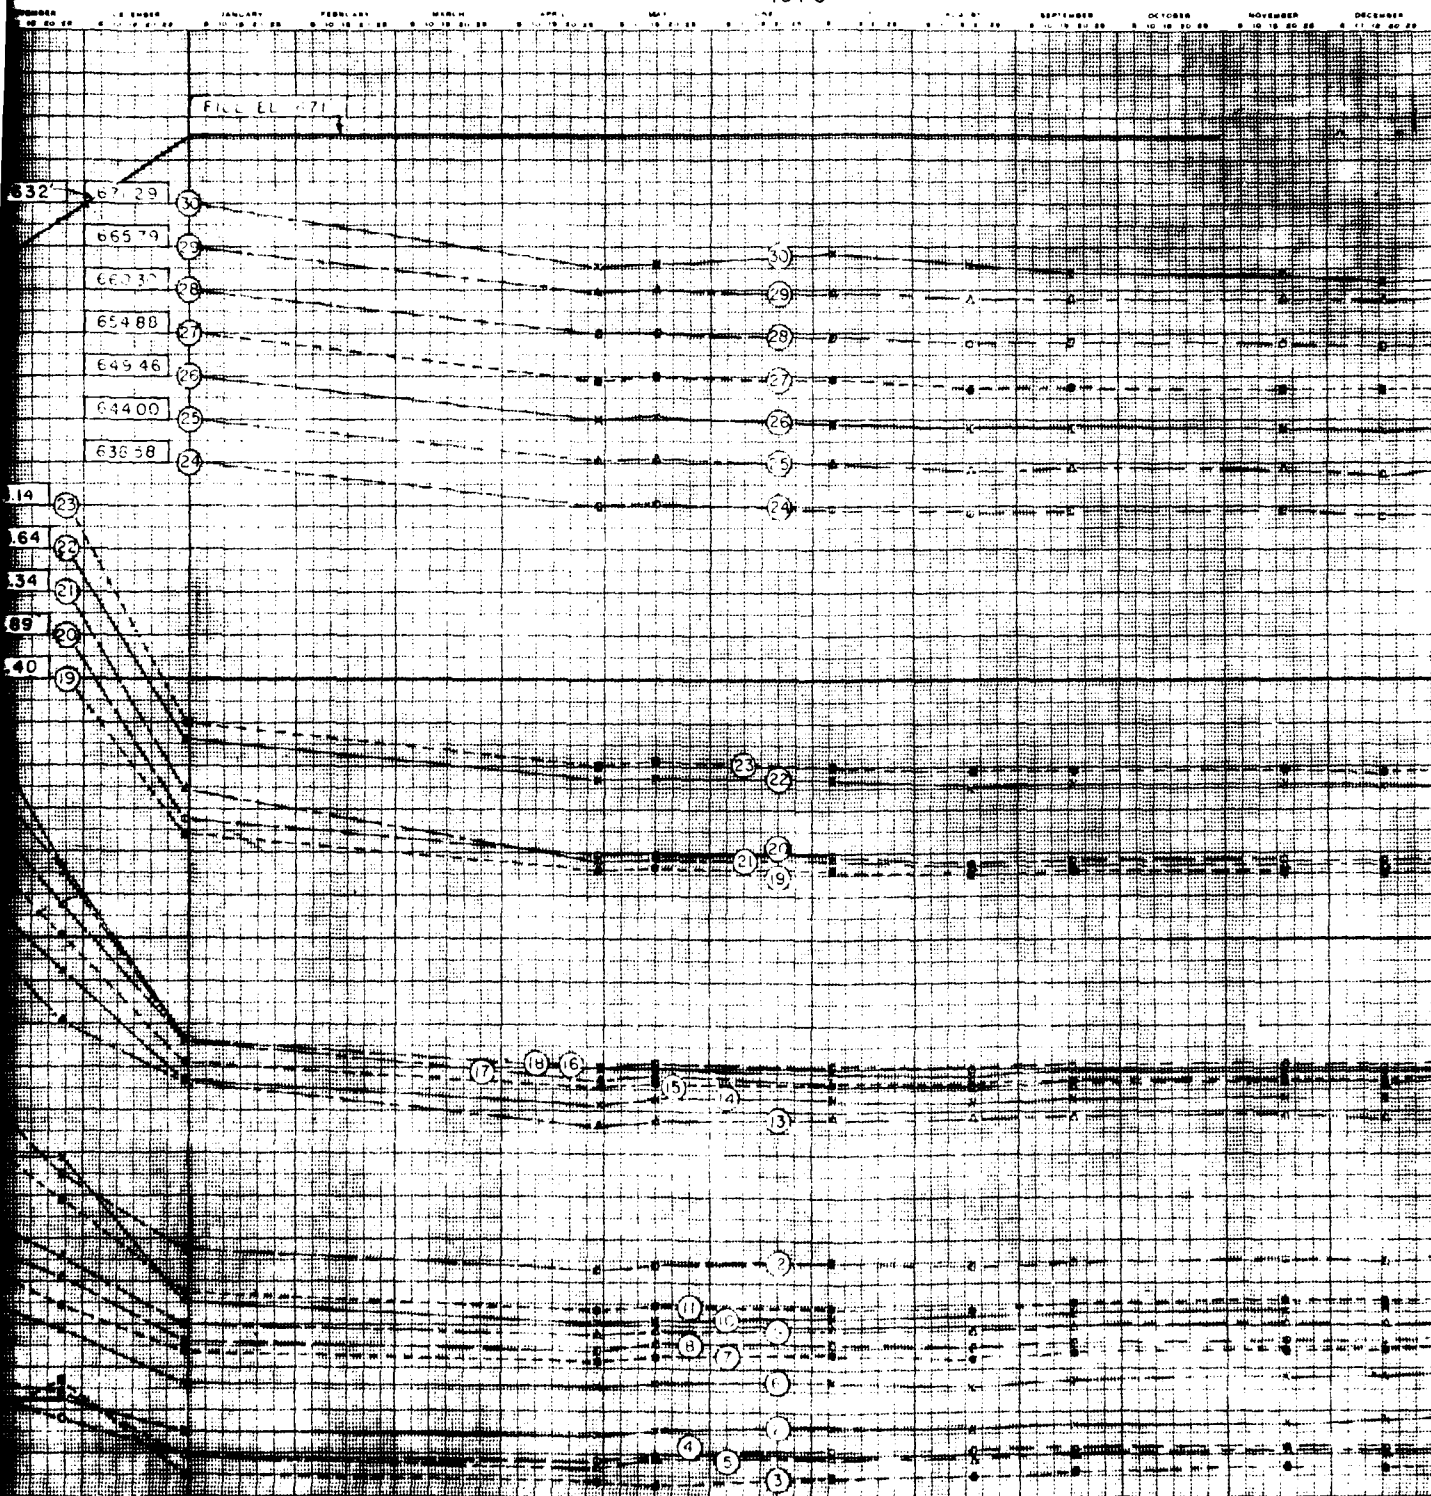
LEHIGH RIVER BASIN  
POHOPOCO CREEK, PA.  
BELTZVILLE LAKE  
SUBSURFACE SETTLEMENT DATA  
VIF - 92 - 2 1969 - 1970

564 30 (10) = INITIALLY INSTALLED BOTTOM  
ELEVATION FOR CASING #10

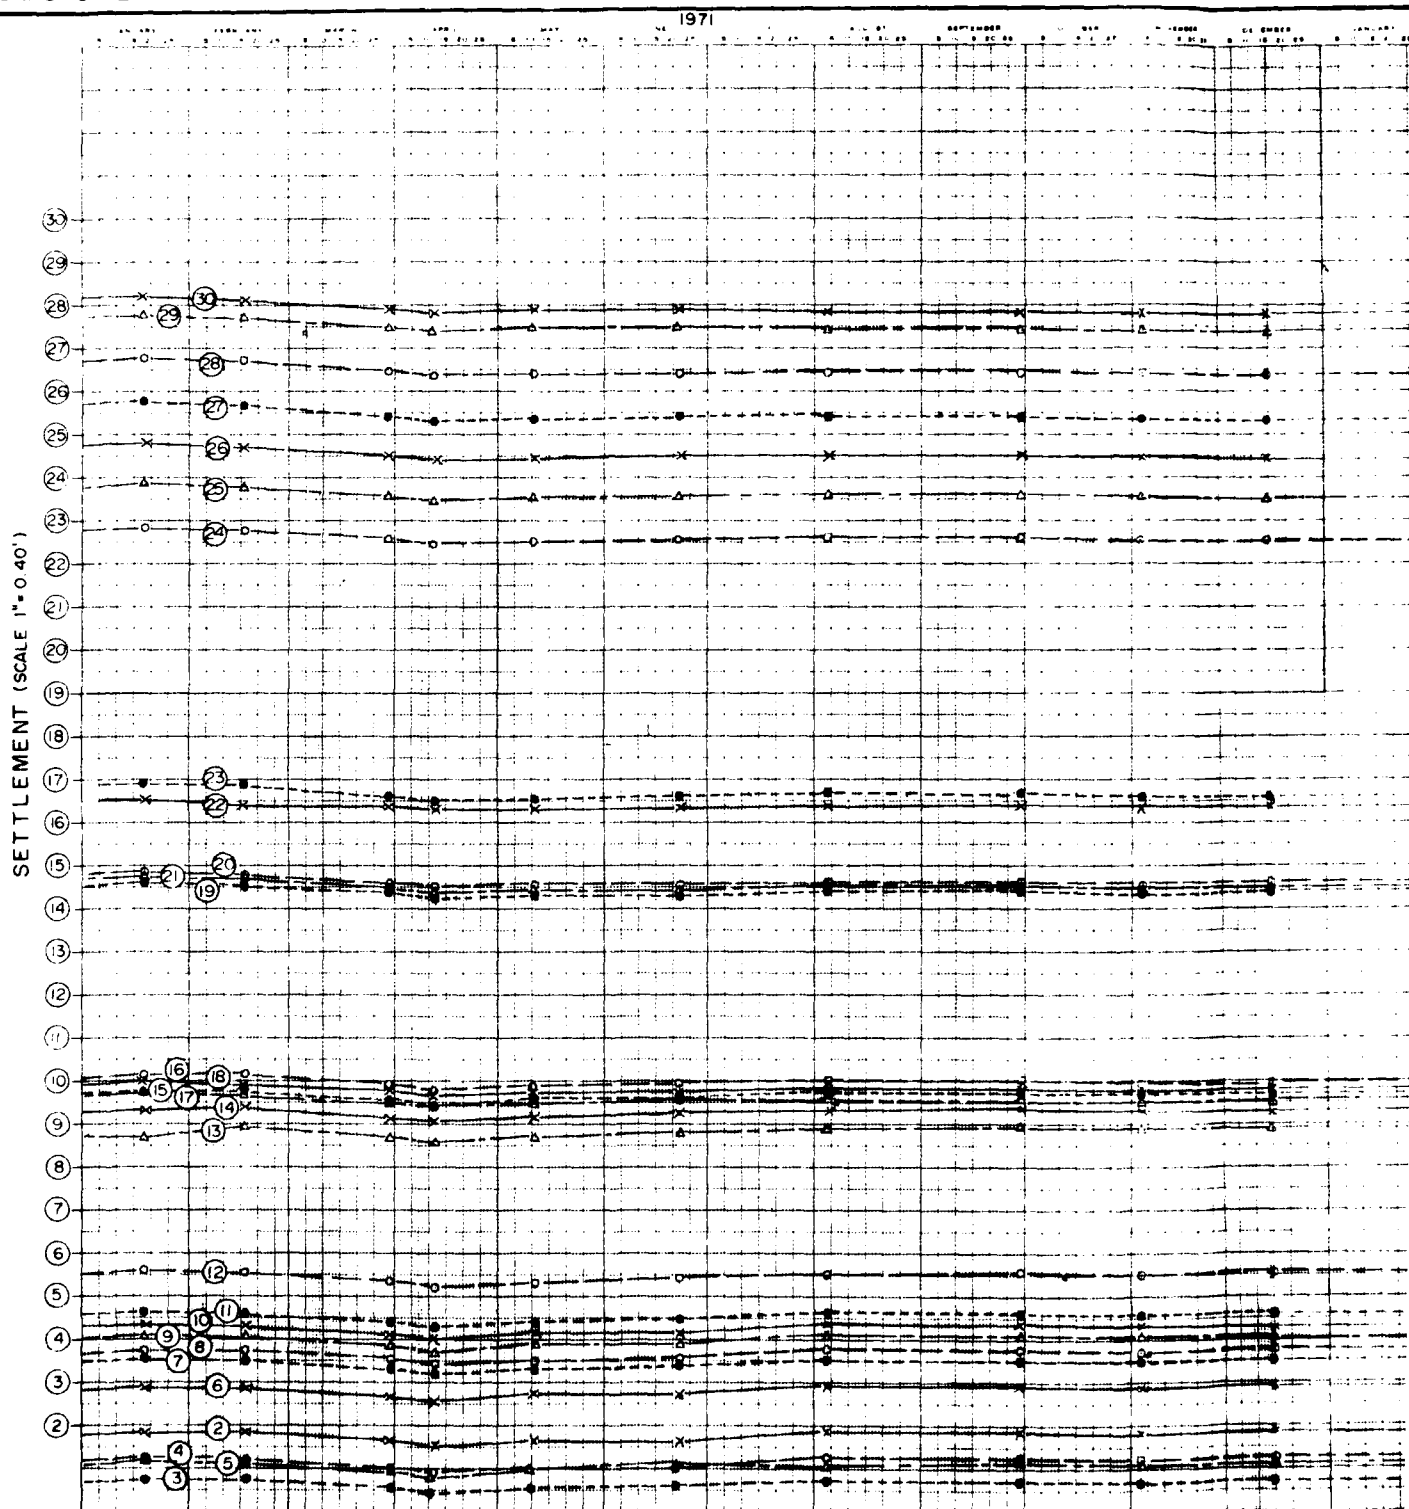
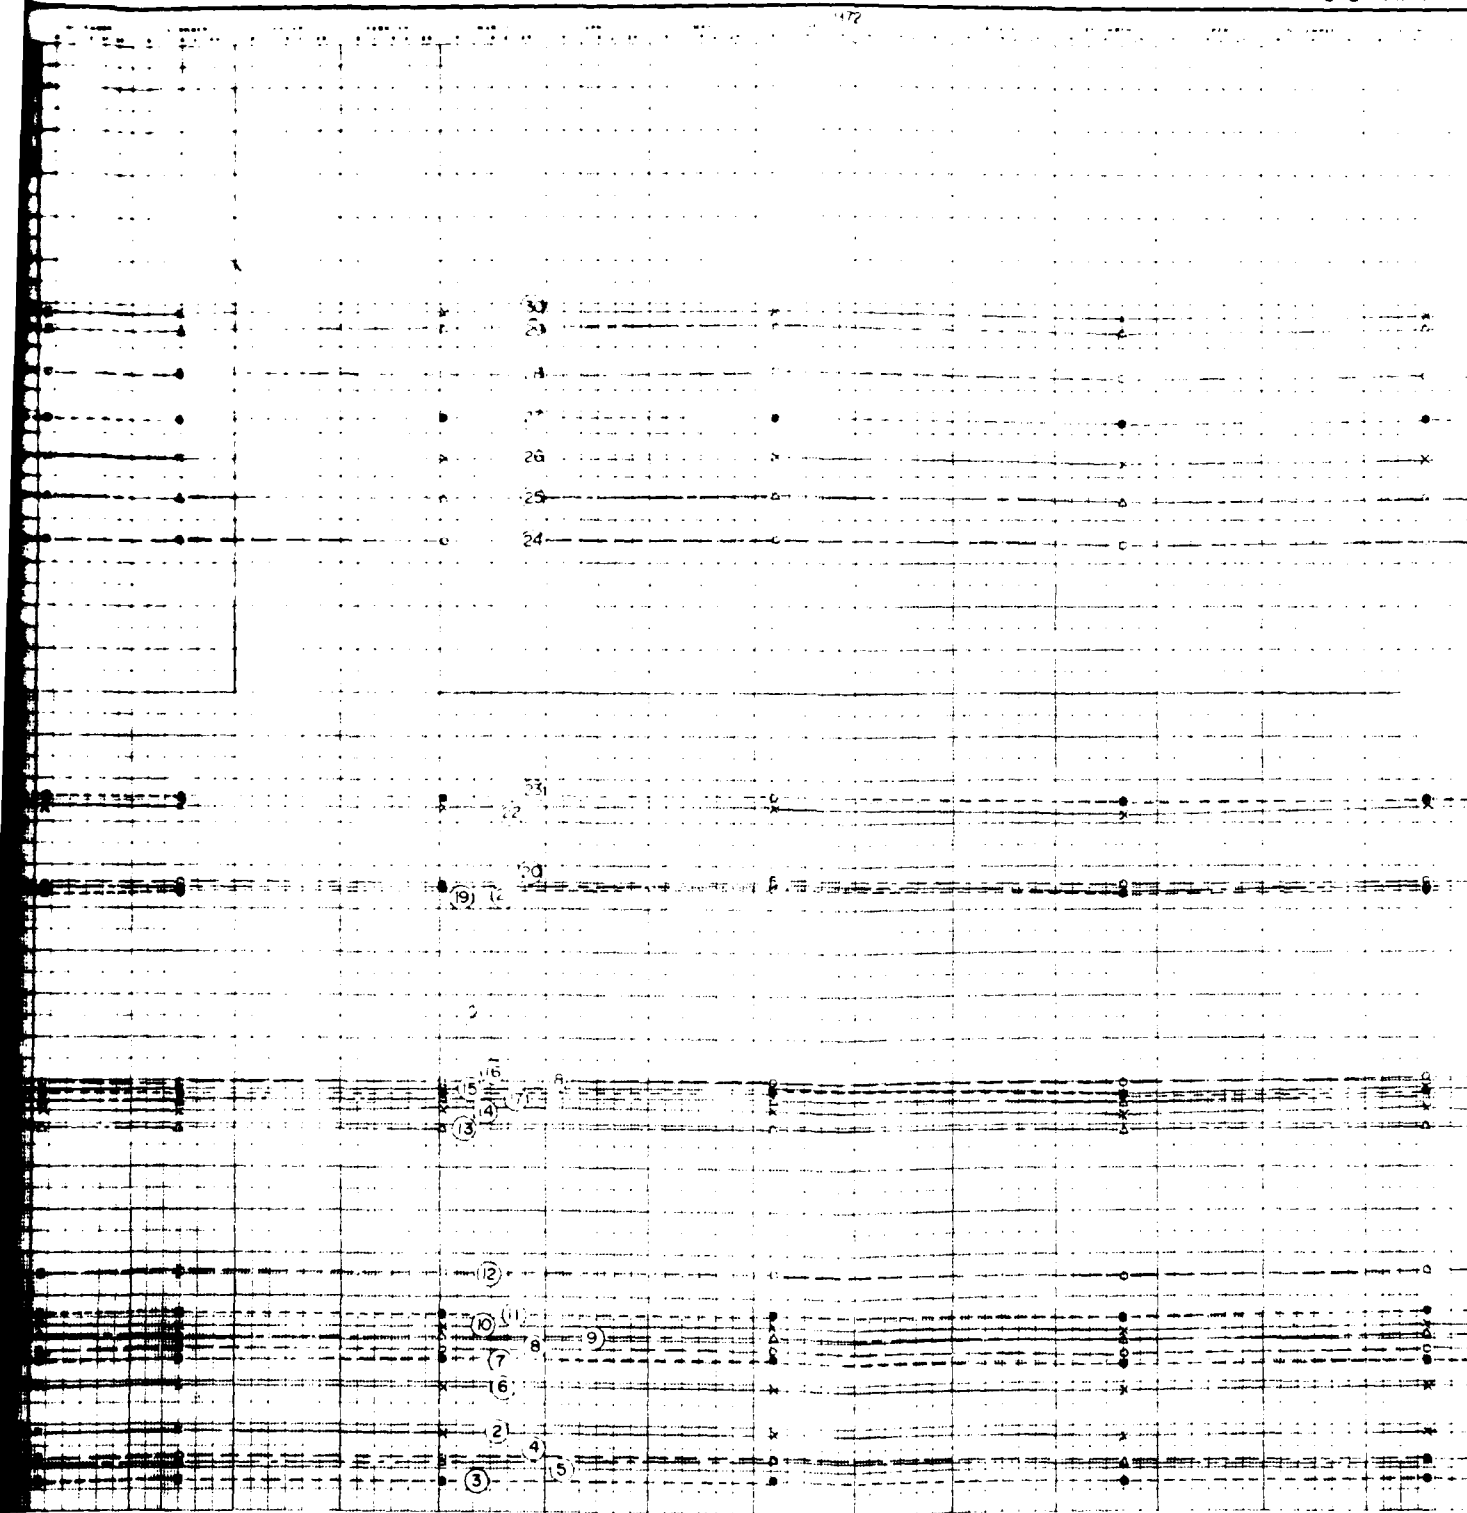
LEHIGH RIVER BASIN  
 POHOPOCO CREEK, PA.  
 BELTZVILLE LAKE  
 SUBSURFACE SETTLEMENT DATA  
 VIF - 92 - 2 1971 - 1972

Initial datum for settlement of section casing (2)

Measured settlement in section casing (2)
